Newsletter of **Environmental, Disaster, and Crises Management Strategies**

Issue No.19 | August 2020

The August 9, 2020 Evia (Central Greece) Flood

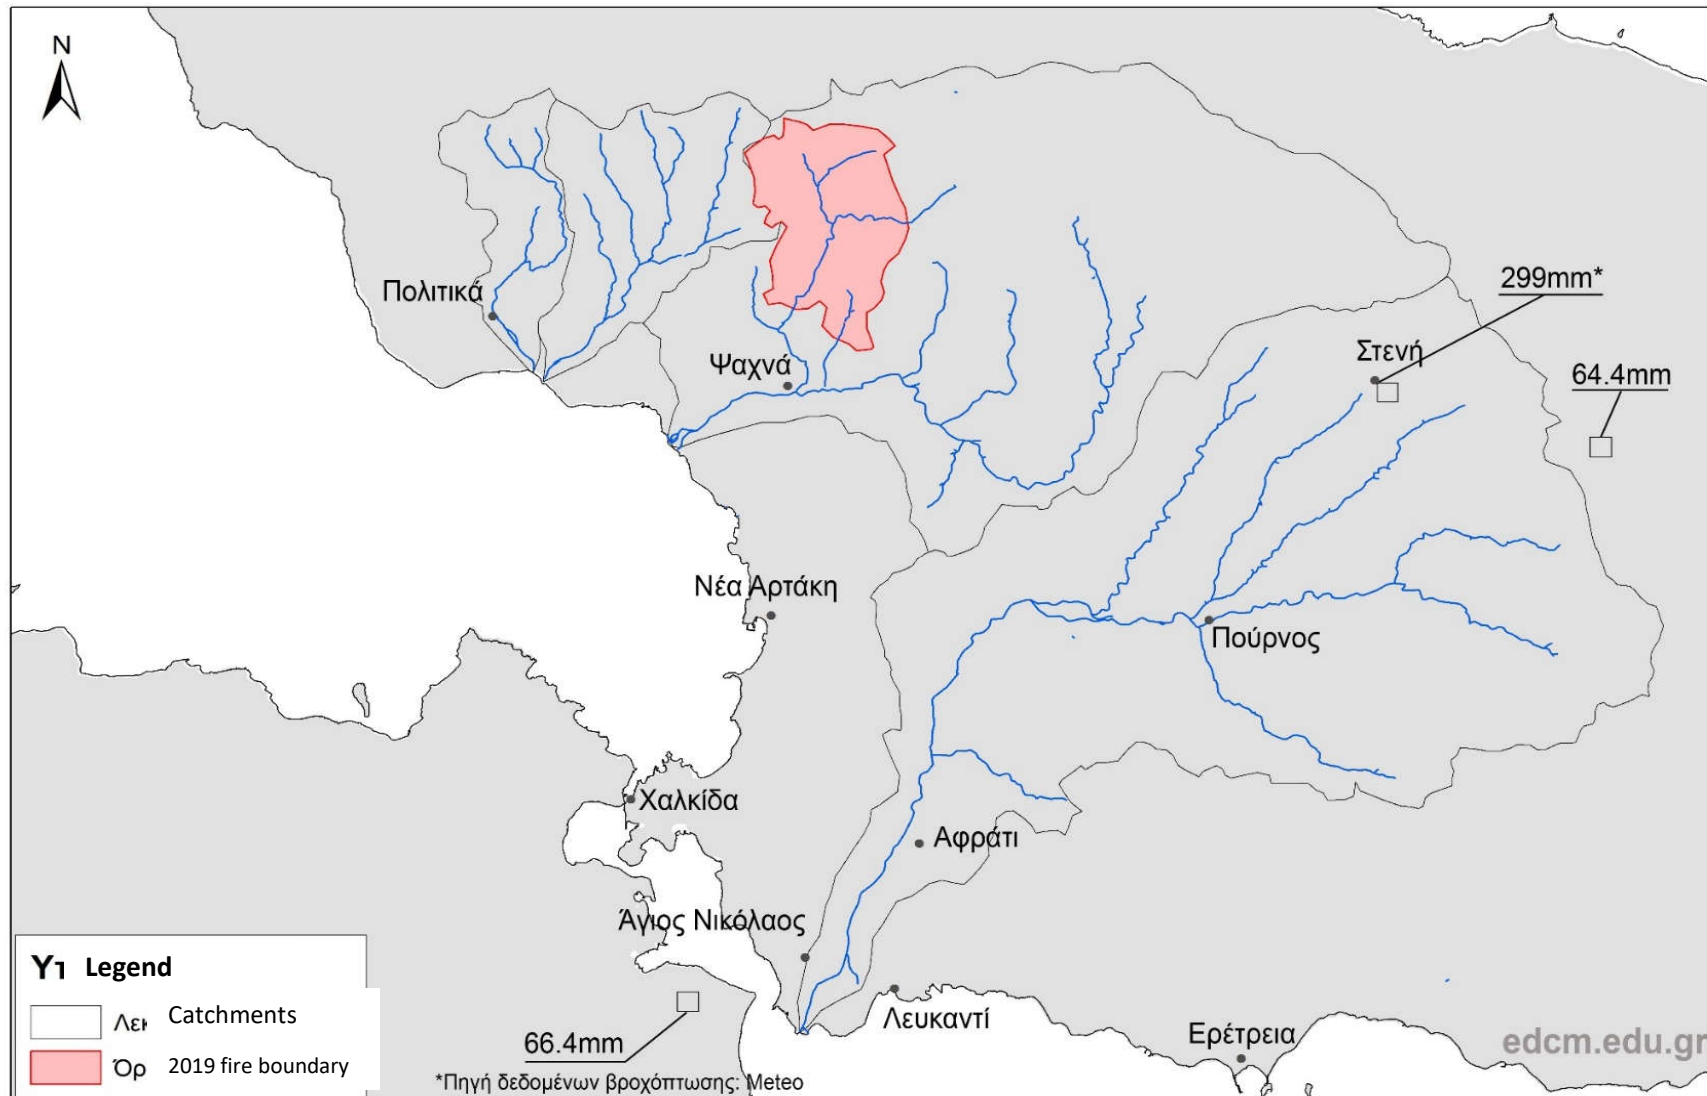
Map of the boundary of the forest fire of August 2019 near Psachna in relation to the catchments hit in the area.

- 4. The role of 2019 Fire:** We can conclude that the role of the 2019 fire in the NE of Psachna town was not crucial to flood triggering. The very limited presence of burned vegetation debris and the small size of the burned area in comparison to the whole basin of Messapios R. indicate a limited role of the fire in flood flows.

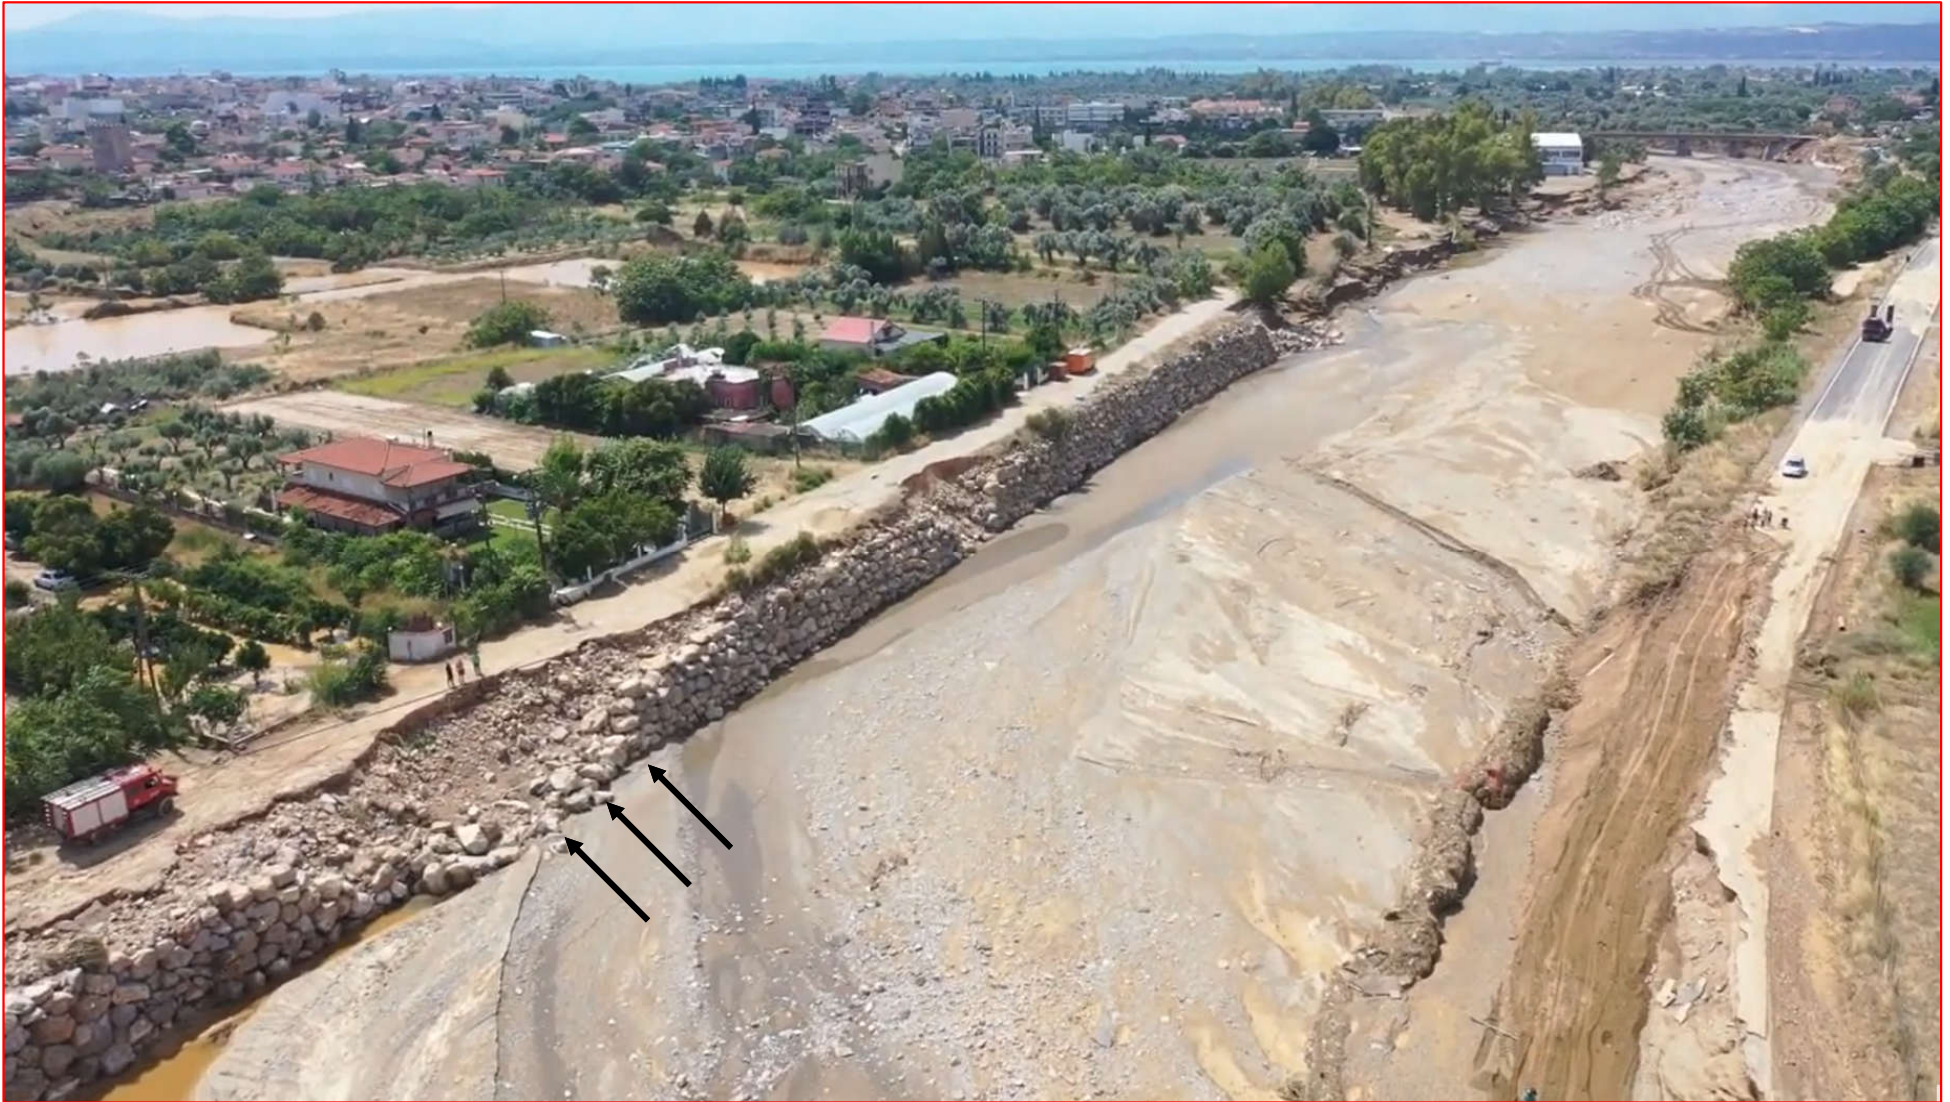
View of eroded bank protection works at the left bank of Lilas R. (looking downstream).

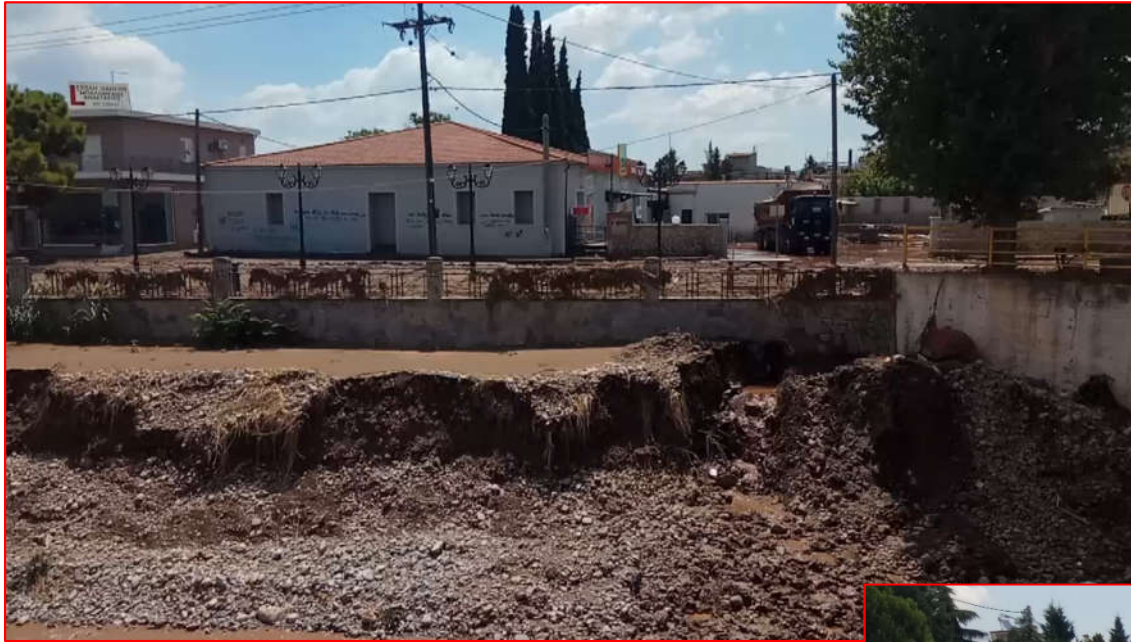
Views of damages in the town of Psachna (main channel)

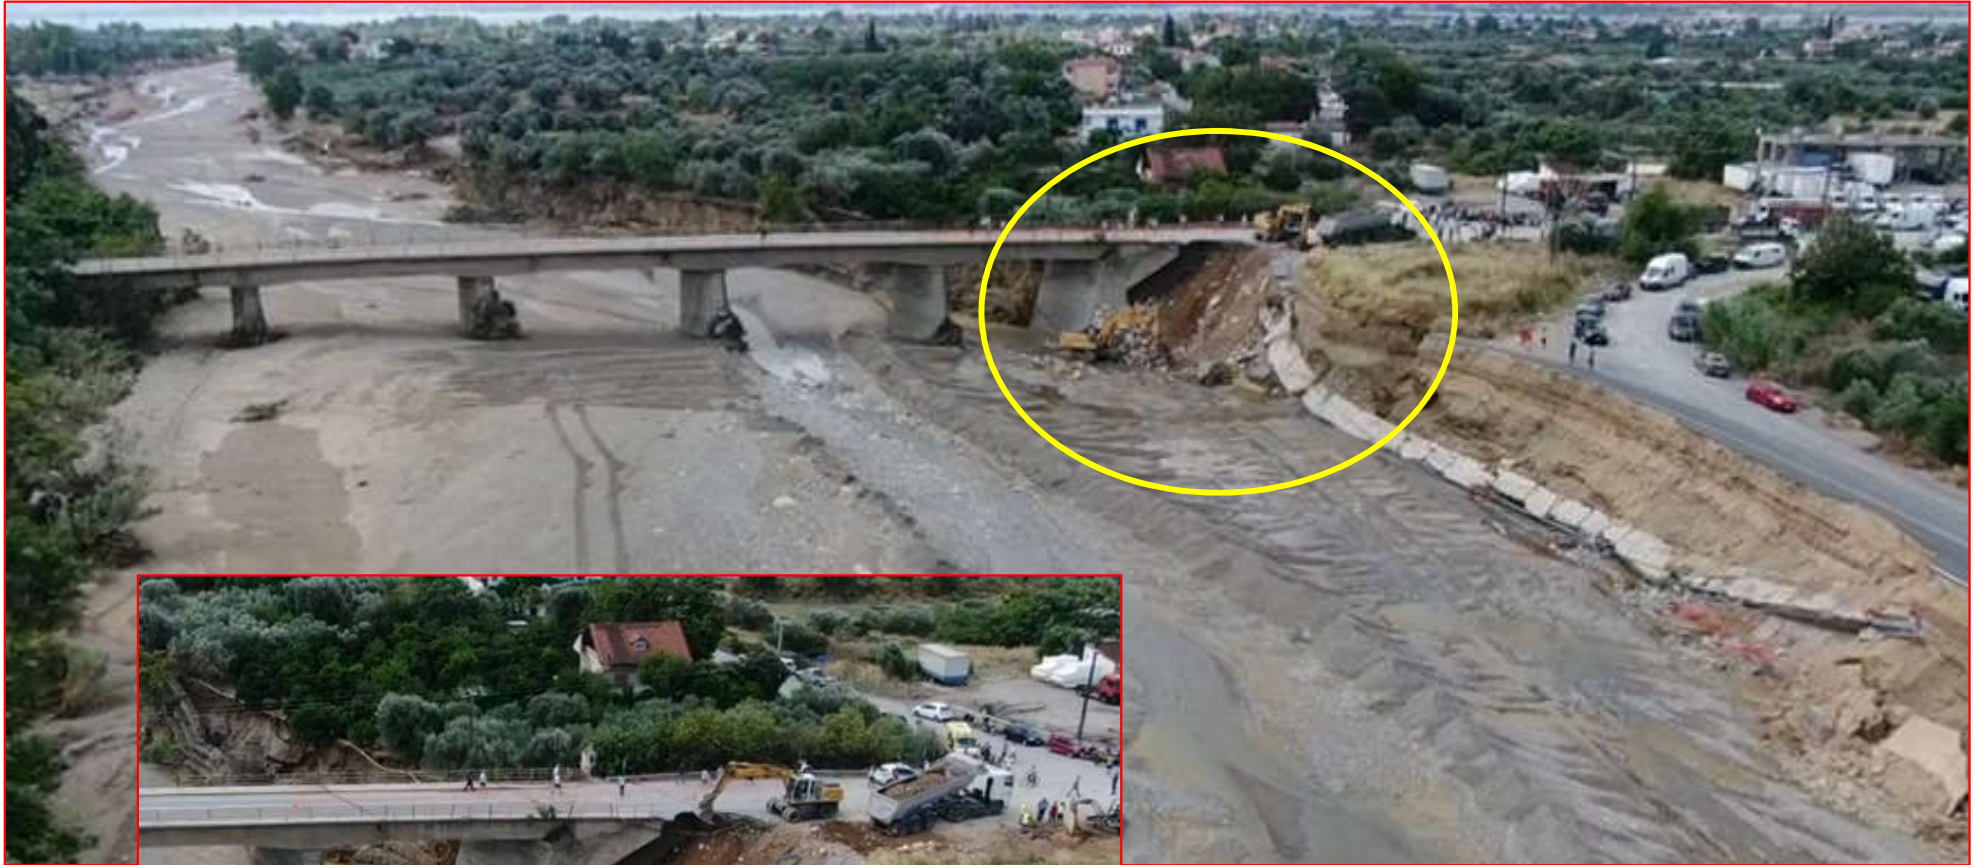
UAV pictures of damages in Vassiliko Bridge (looking downstream)

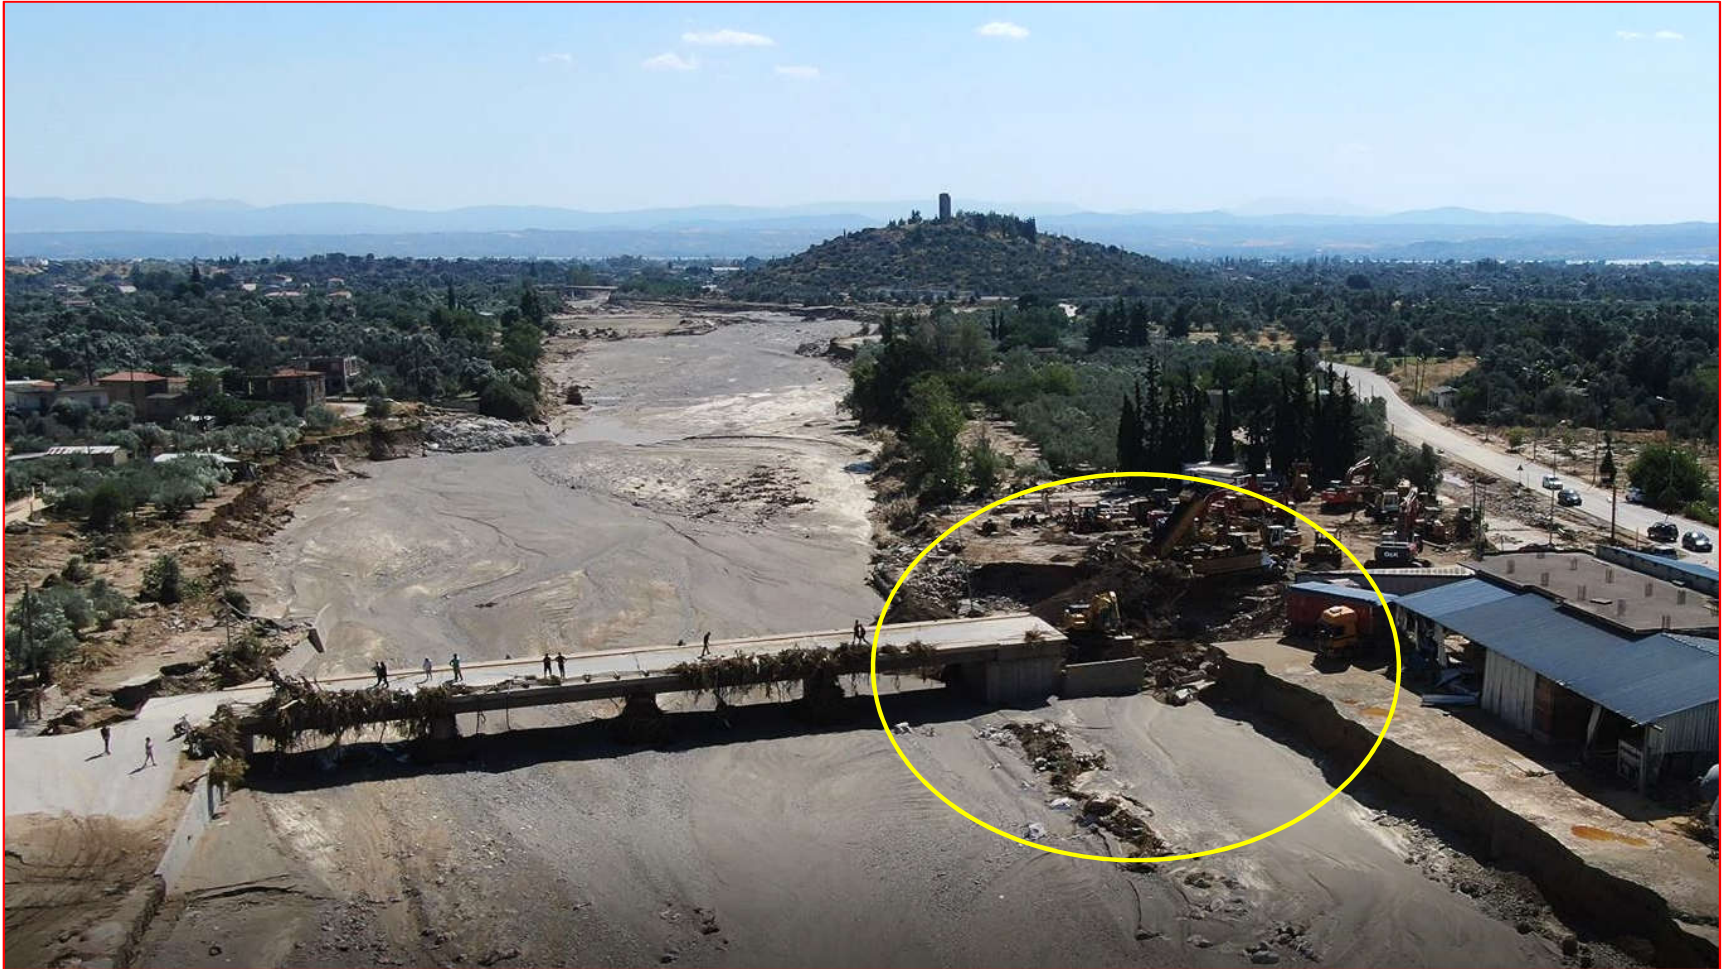
Άποψη της γέφυρας του Αφρατίου προς τα κατόντη στην οποία σημειώνεται λόγω διάβρωσης των πρανών γύρω από το ακρόβαθρο (τυπική εικόνα επιπτώσεων σε γέφυρες από την πλημμύρα).

View of Afrati Bridge looking downstream. Its right side has completely collapsed due to erosion of the river bank.

- 6. Infrastructure and human intervention:** We recorded multiple damages on road infrastructure (particularly single-span bridges). In some cases, initial surveys indicate that critical cross sections were diminished by human interventions, leading to intensification of flood phenomena locally.

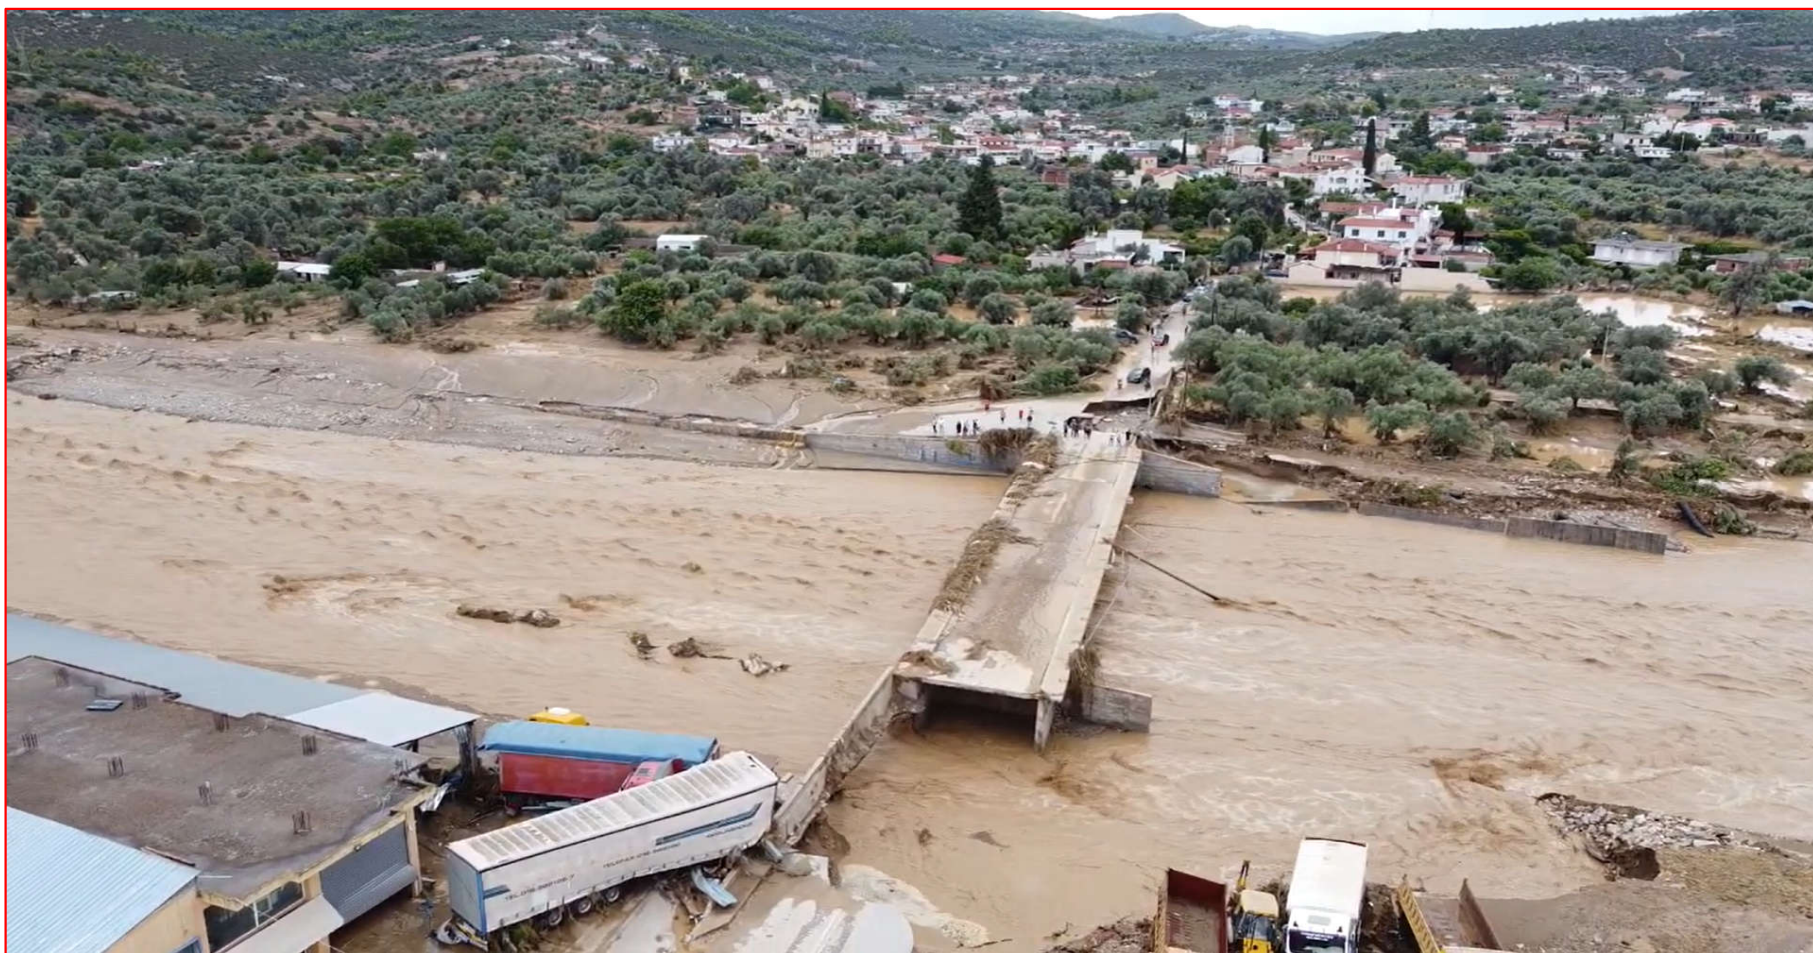
Άποψη της γέφυρας του Αφρατίου στην οποία σημειώνεται λόγω διάβρωσης των πρανών γύρω από το ακρόβαθρο (τυπική εικόνα επιπτώσεων σε γέφυρες από την πλημμύρα).

View of Afrati Bridge looking south. Its right side has completely collapsed due to erosion of the river bank.

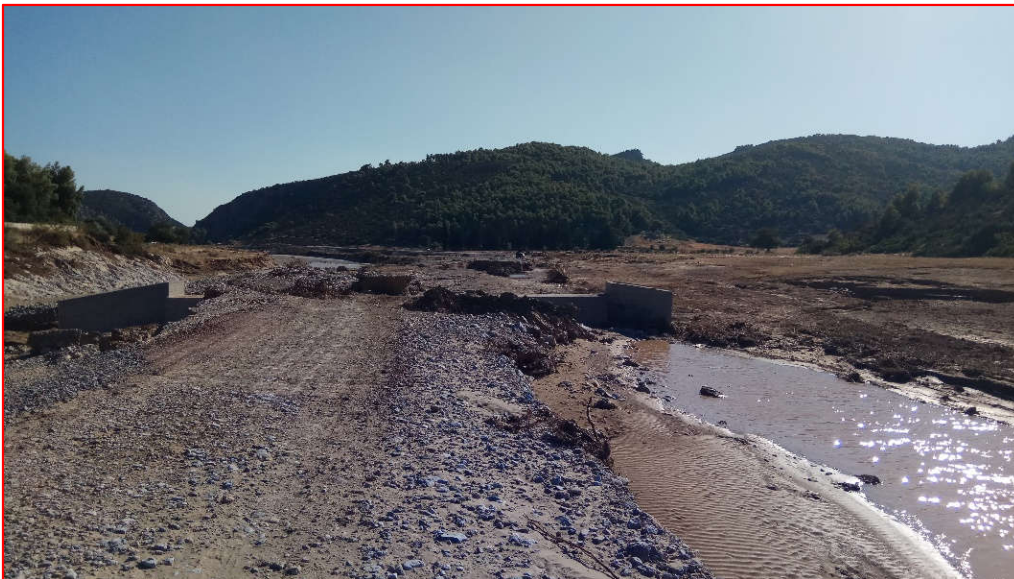
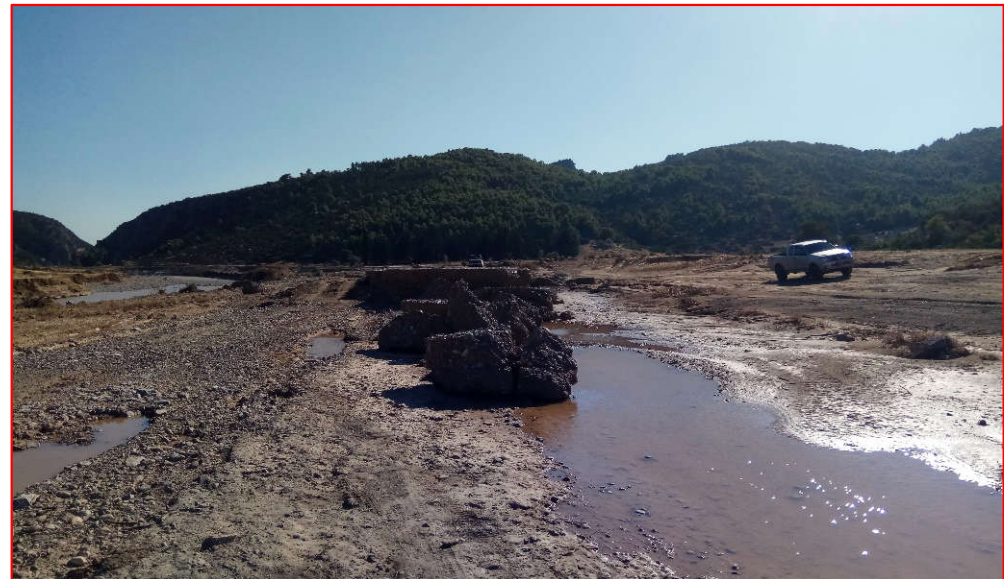
COLLAPSED ROAD EMBANKMENTS (AFRATI – PISSONAS)

Collapsed and eroded road embankments, scoured asphalt deck.

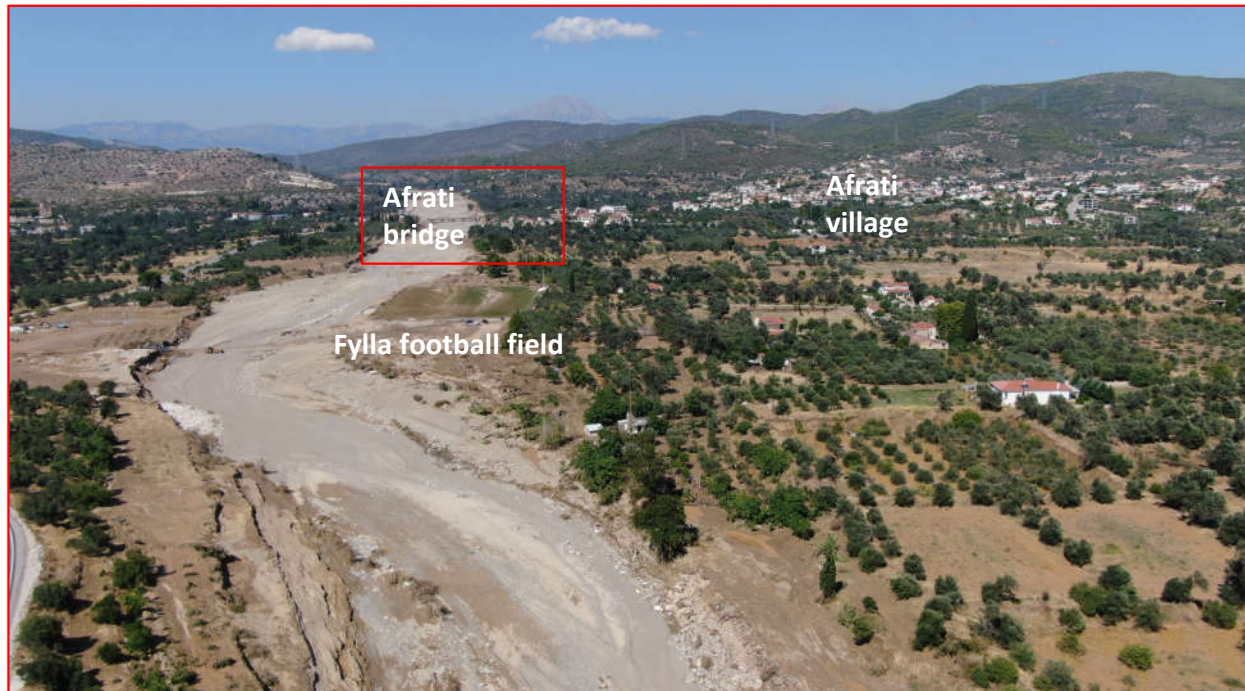
UAV images of Afrati Bridge, Fylla football field and the general area.

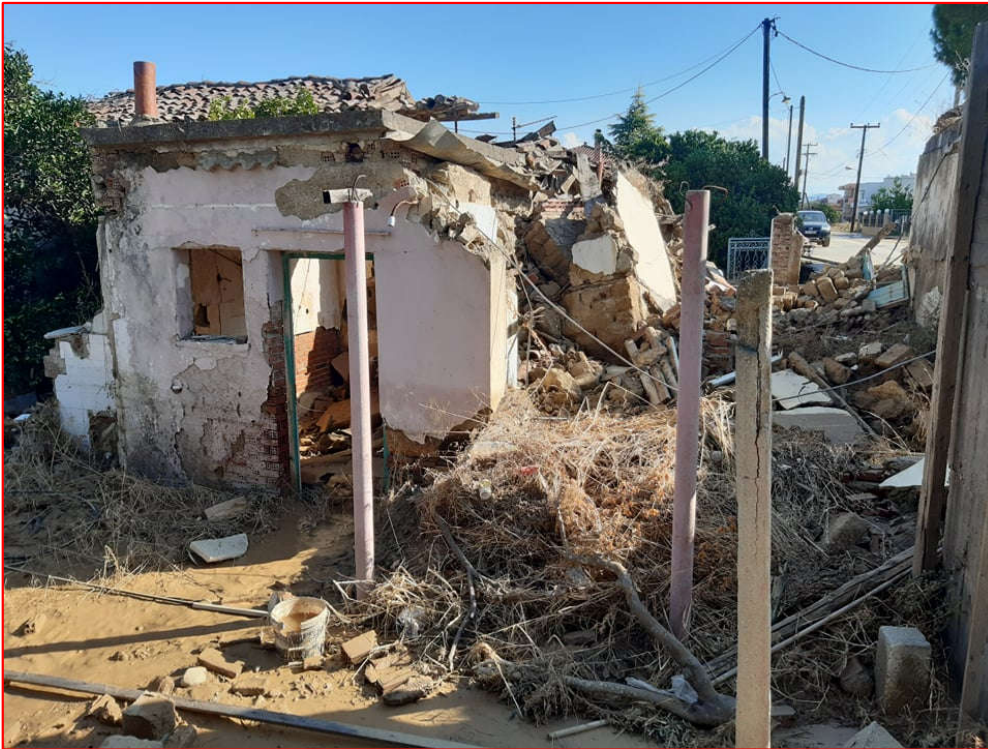
Impacts on stone-built houses (Lilas R. floodplain)
Complete collapse

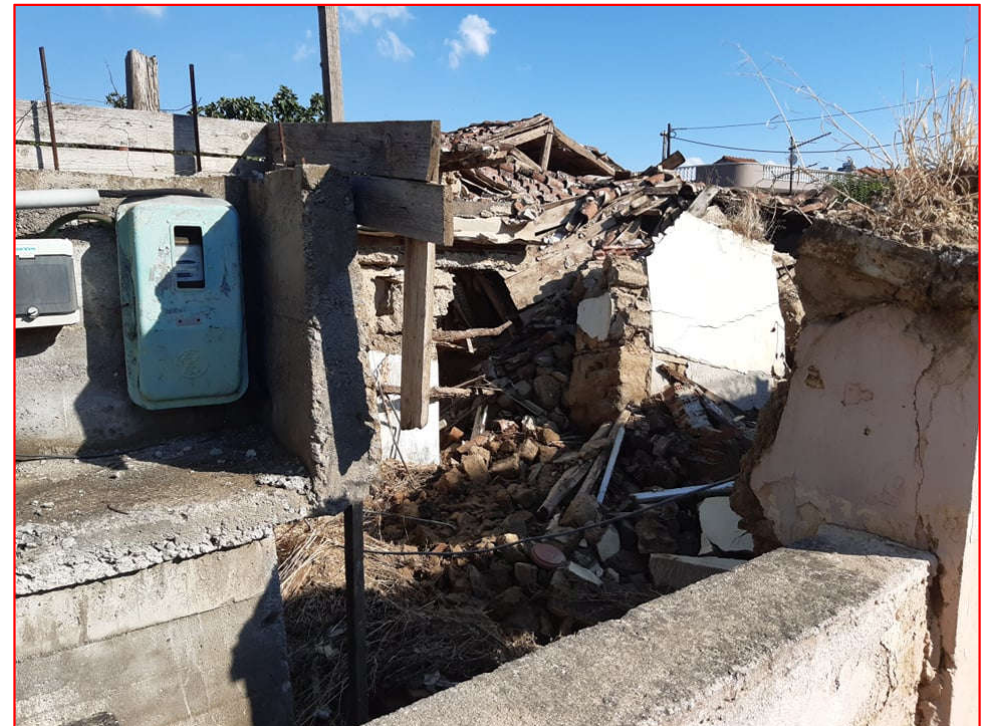
Impacts on stone-built houses (Lilas R. floodplain)
Complete collapse

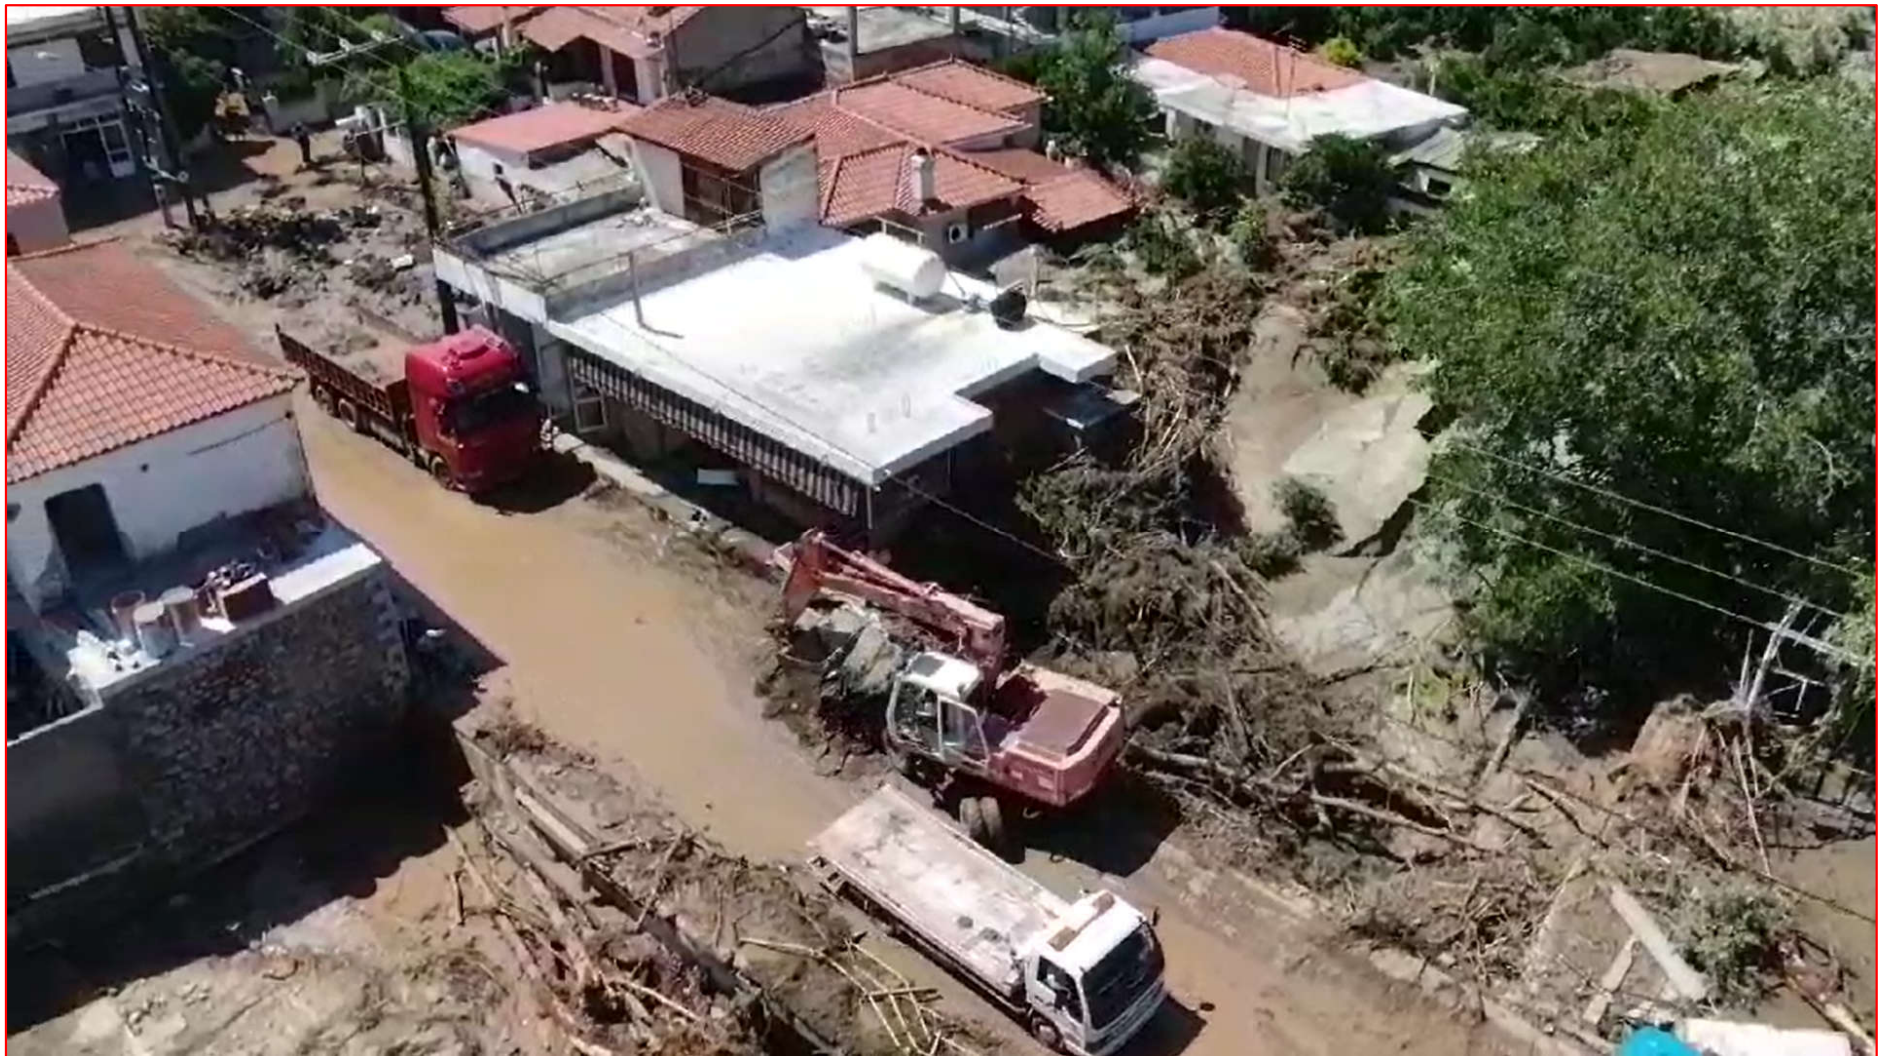
Φράξιμο αγωγού από φερτά υλικά στα Πολιτικά

Bridge cross-section clogging from vegetation
Debris captured from UAV at Politika village

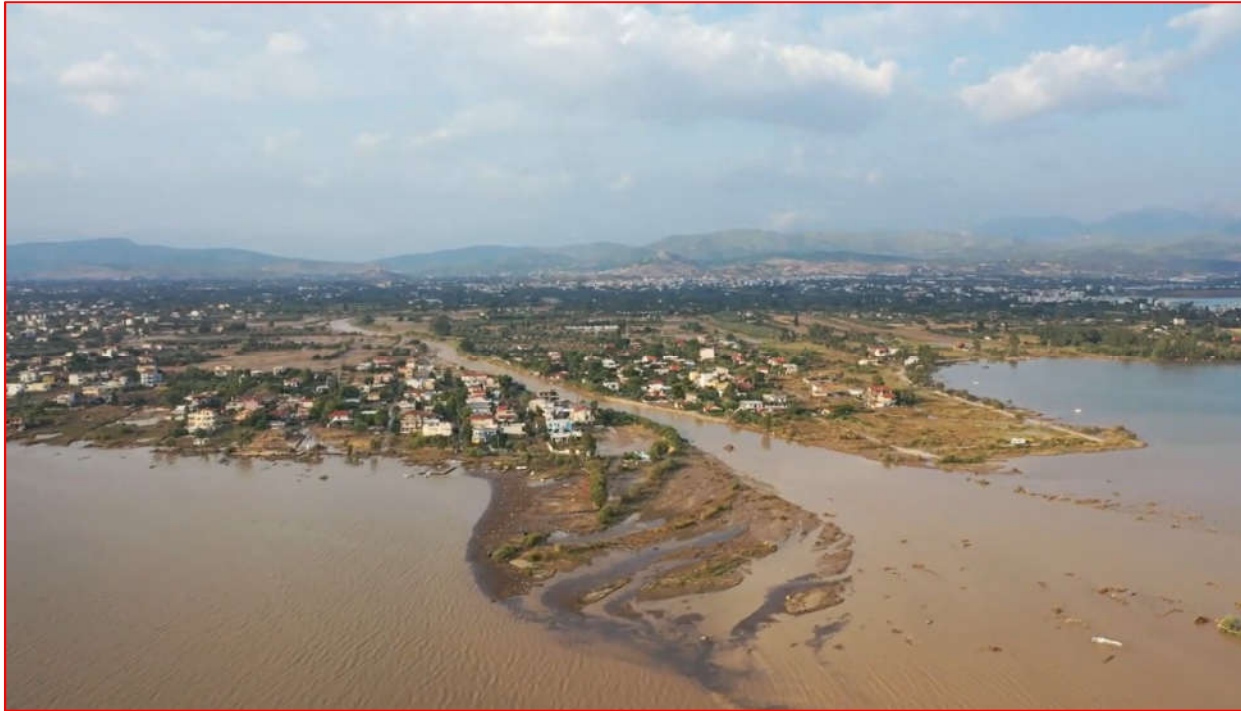
Lilas River outlet

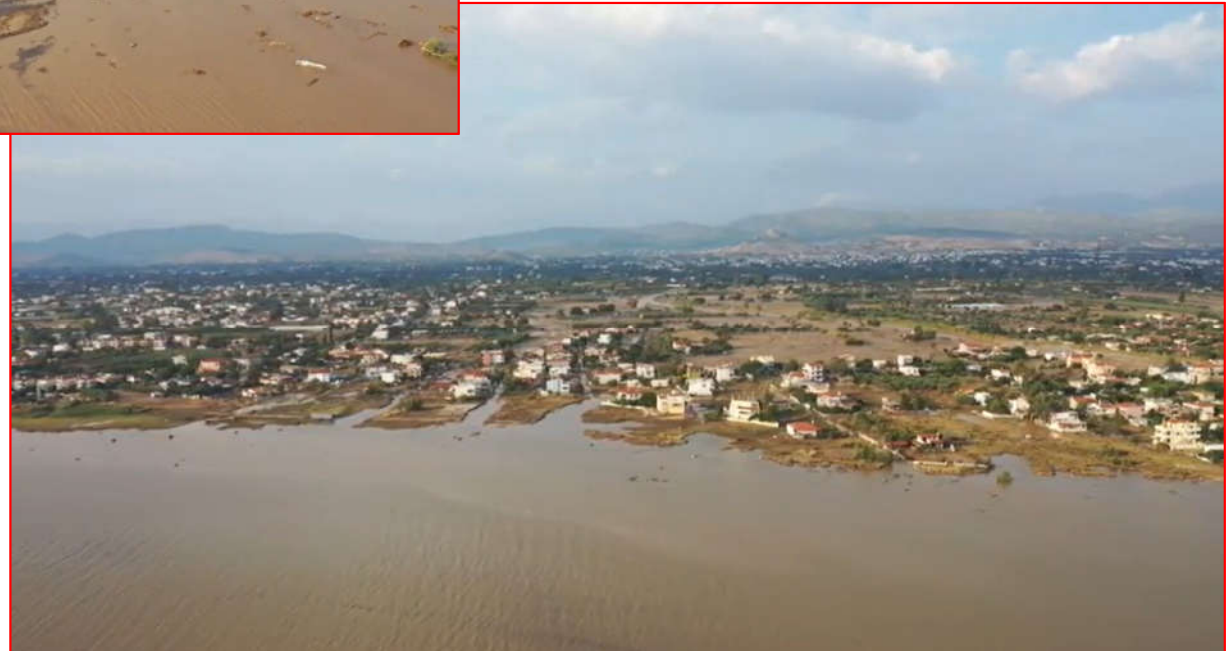
Lilas River alluvial fan

- 5. River outlet Morphology:** At its outlet Lilas R. forms an alluvial fan upon which the towns of Lefkanti and Mpourtzi have been built. Although there is limited infrastructure on the river channel itself hampering flood flows, the presence of human settlements on the alluvial fan lead to high exposure and thus conditions of high risk. The fan functioned as expected, as it was inundated almost completely.

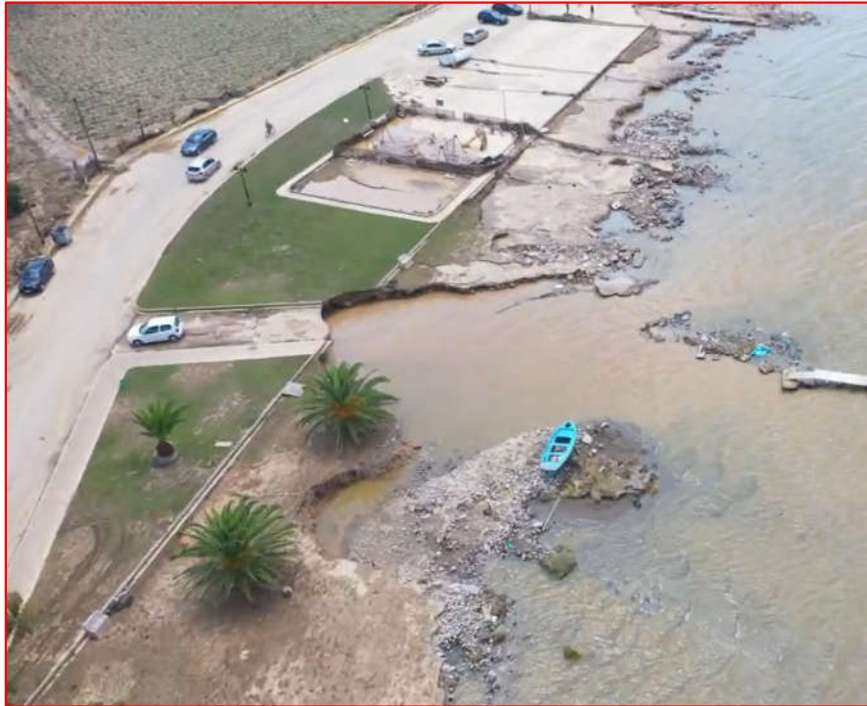
Erosion of coastal infrastructure
at Mpourtzi

Erosion rills at Lefkanti beach

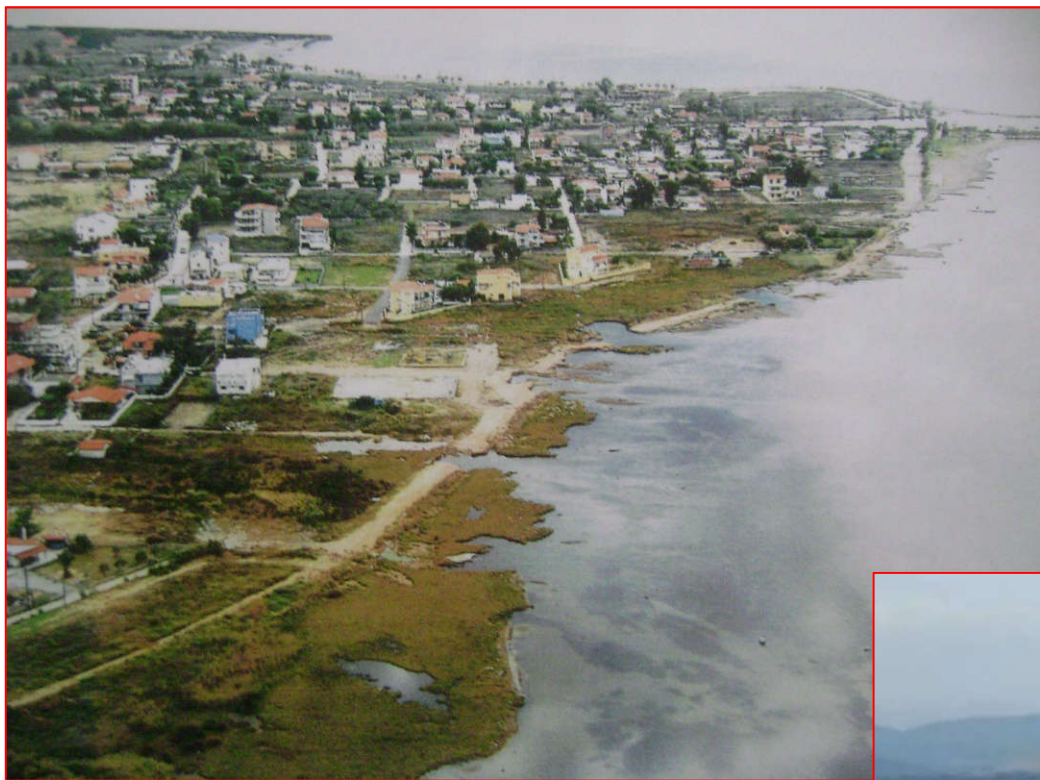
View of the coastal area after the 2020 flood in Lilas R.

Άποψη της ακτογραμμής μετά την πλημμύρα του Αυγ. 2020 κοντά στις εκβολές του Λήλαντα Ποταμού

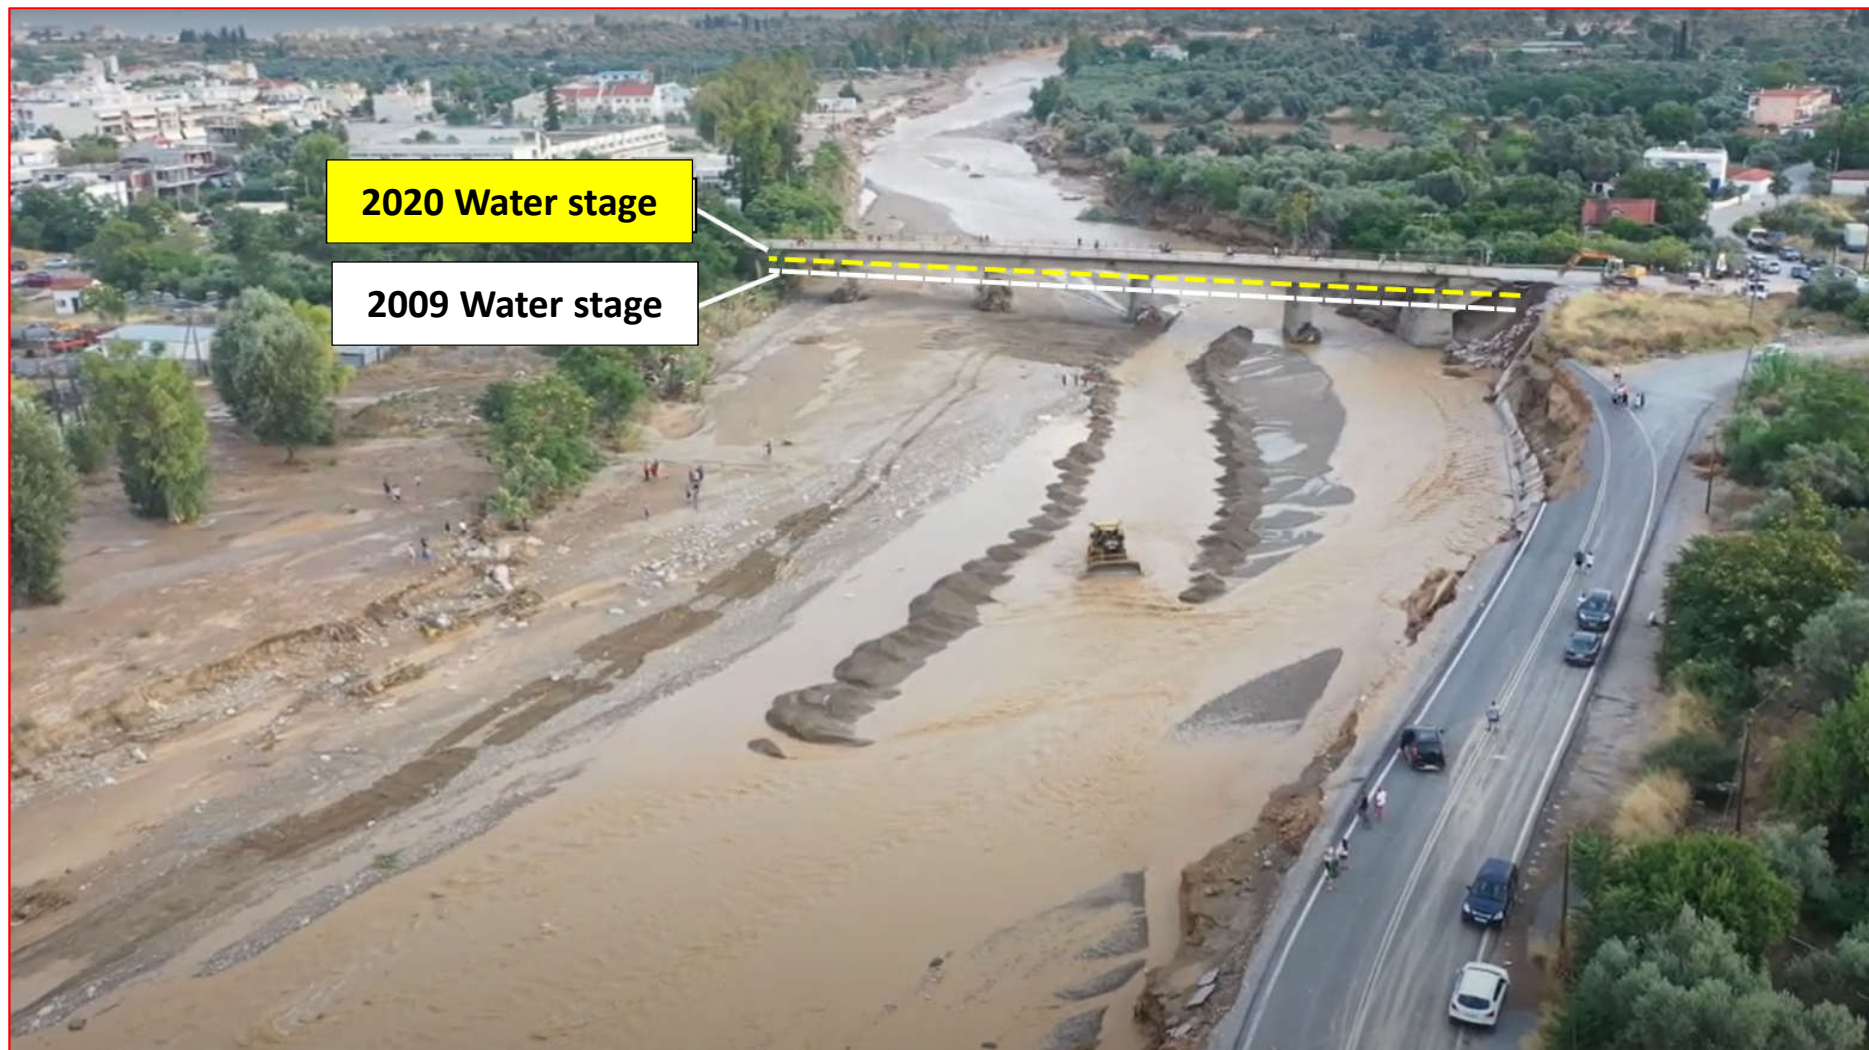
Άποψη της γέφυρας Βασιλικού προς τα κατάντη, όπου καταγράφονται προσεγγιστικά οι στάθμες των πλημμυρών του Αυγούστου 2020 και του Σεπτεμβρίου 2009 με βάση τα σημάδια της πλημμύρας (high water marks) στα βάθρα της γέφυρας (έρευνα πεδίου Αύγουστος 2020 και Σεπτέμβριος 2009).

View of Vasiliko Bridge towards downstream, presenting the approximate water maximum water stage during the 2009 and 2020 flood flows (white and yellow lines) using high water marks detected in post flood surveys.

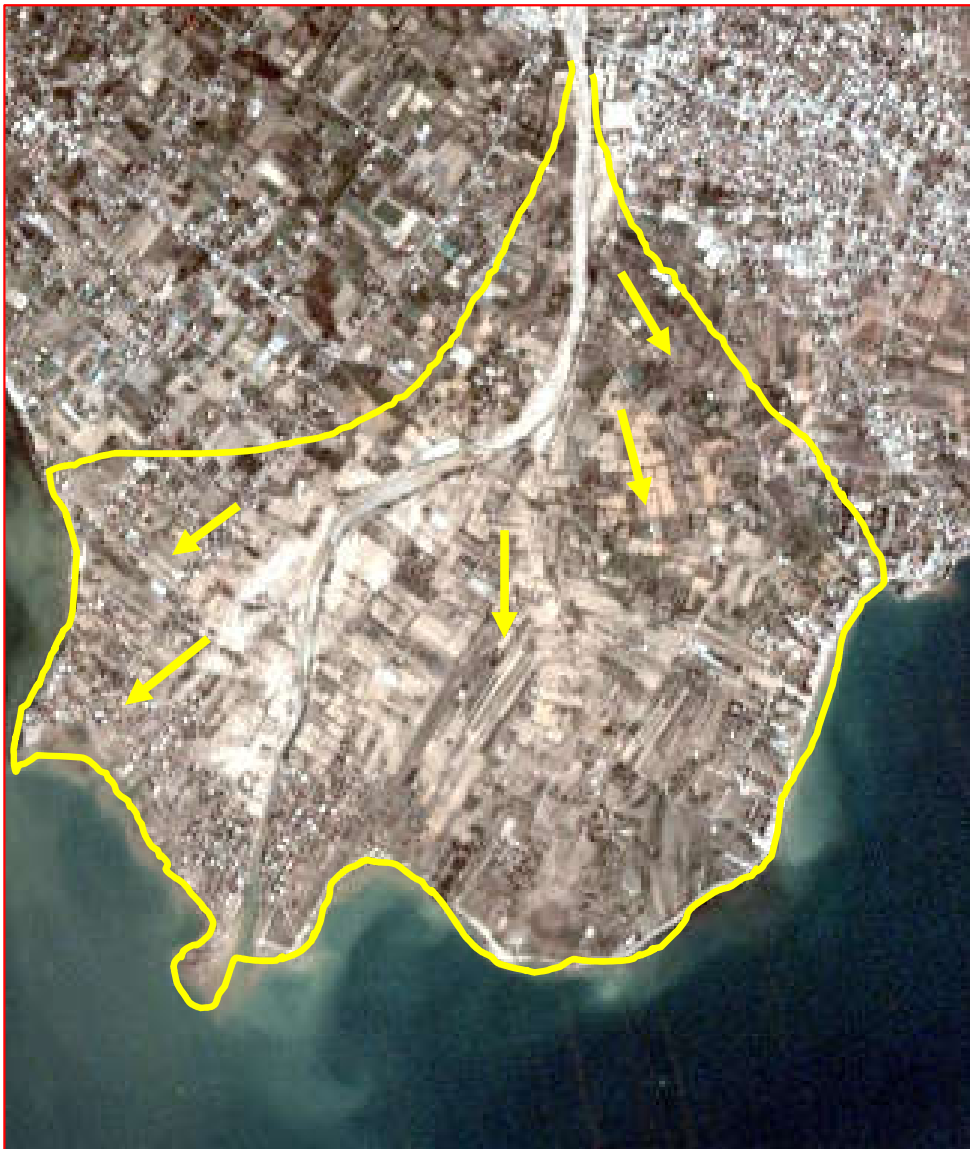
Flooding of alluvial fan

Ενεργοποίηση του αλλουβιακού ριπιδίου
